THE MALDEN SURVEY

A REPORT ON THE CHURCH PLANTS OF
A TYPICAL CITY, SHOWING THE USE
OF THE INTERCHURCH WORLD MOVE-
MENT SCORE CARD AND STANDARDS
FOR RATING CITY CHURCH PLANTS

Compiled Under the Direction of
WALTER SCOTT ATHEARN

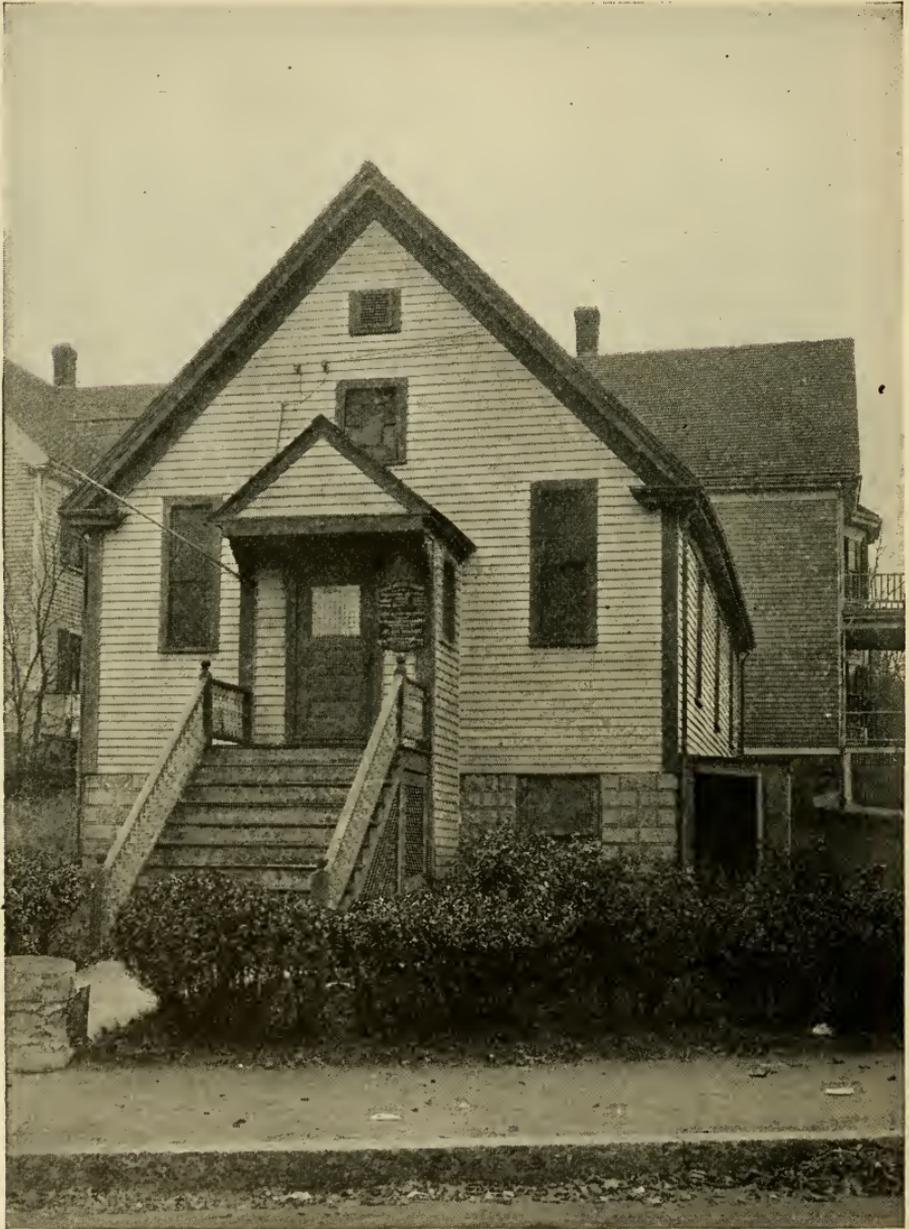
ILLUSTRATION 17. UNION BAPTIST CHURCH

About half of the score on this building has been allotted to the site. There is little else about this plant that has anything to commend it. It represents very little achievement on the part of any community group and should be replaced at the earliest moment by a standard plant.

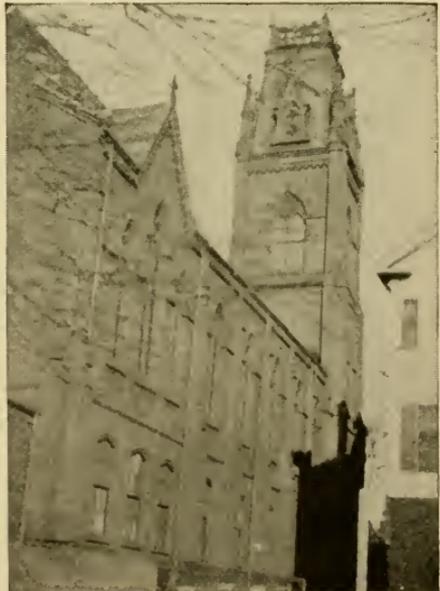
ILLUSTRATION 21. SIDE VIEW OF FIRST CONGREGATIONAL CHURCH SHOWING HOW ADJOINING BUILDING SHADOWS A CLASS ROOM

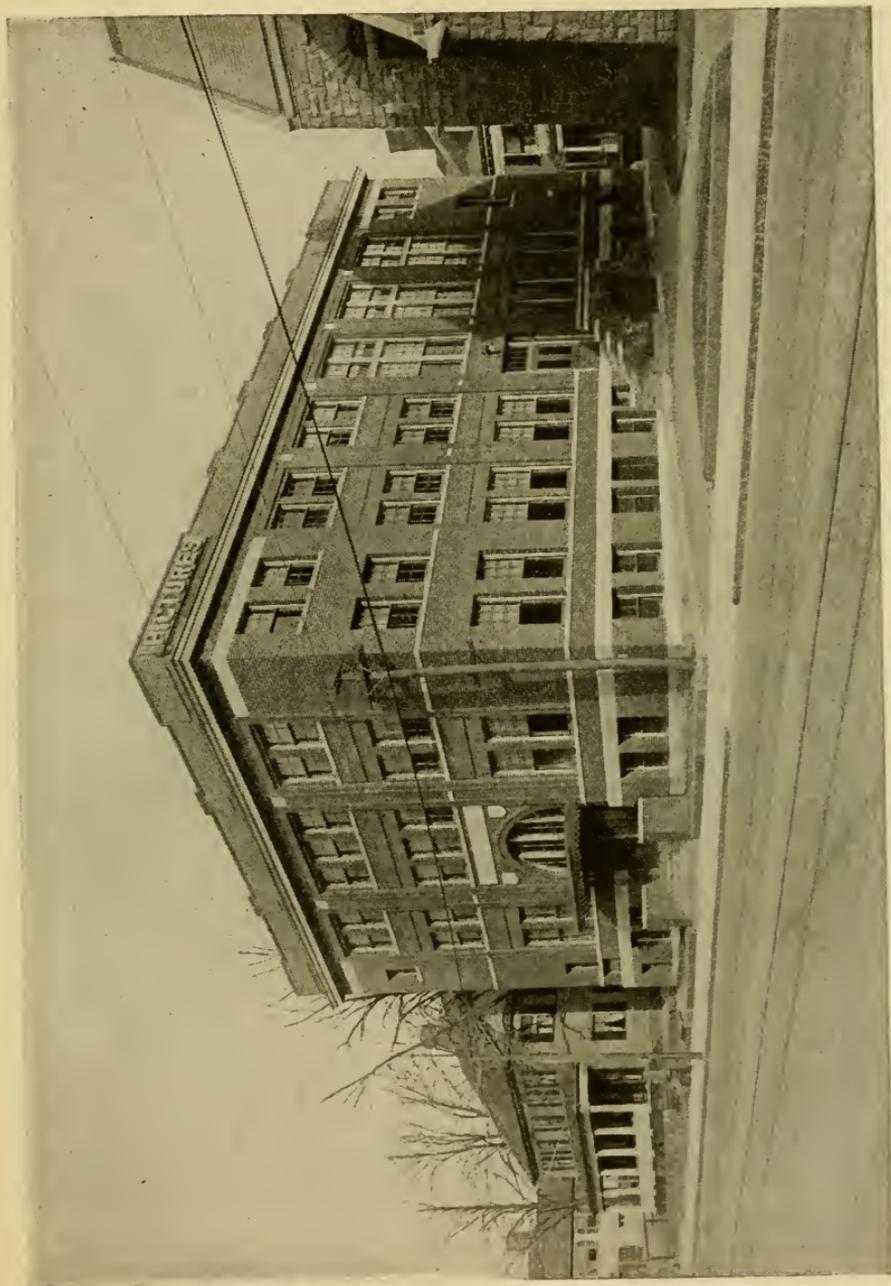
ILLUSTRATION 22. PARISH HOUSE, FIRST BAPTIST CHURCH, WHERE MALDEN PROVIDES ITS BEST PHYSICAL PLANT FOR RELIGIOUS EDUCATION. HOME OF COMMUNITY SCHOOL OF RELIGIOUS EDUCATION

Perhaps the most outstanding result of the effect of an inadequate site in a particular situation is that evident from study of illustration 22 and 20, pages 59 and 57. The religious school building of the First Baptist plant presents an attractive appearance from the church side. The site, however, is so small that it was considered necessary to build this structure with one side close to the neighboring property line. The building, on this side, has been given a blank wall, thereby detracting to a considerable degree from its beauty both within and without and from the advantages that accrue from good natural lighting of classrooms. A school building of this size requires a site sufficiently large for play and pageantry purposes.

face the weather. A covered way, conveniently entering both buildings, would meet this defect. See illustration 22, page 59.

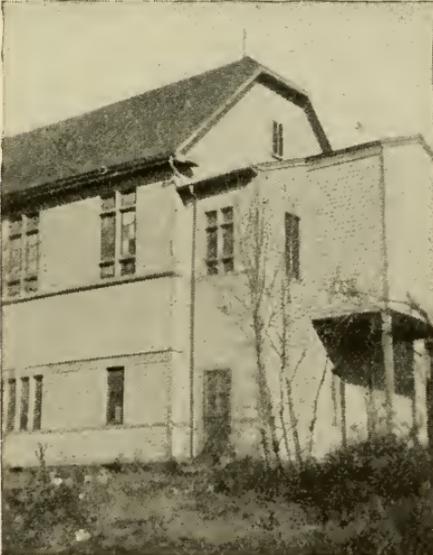
ILLUSTRATION 23. THE POORLY PLANNED MAPLEWOOD CONGREGATIONAL CHURCH ON ILL-KEPT GROUNDS

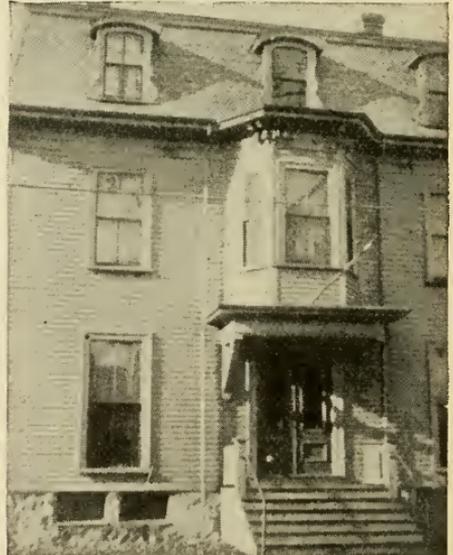
ILLUSTRATION 24. UNATTRACTIVE AND INADEQUATE TEMPORARY HOUSING FOR ST. PAUL'S SUNDAY SCHOOL ATTENDANTS

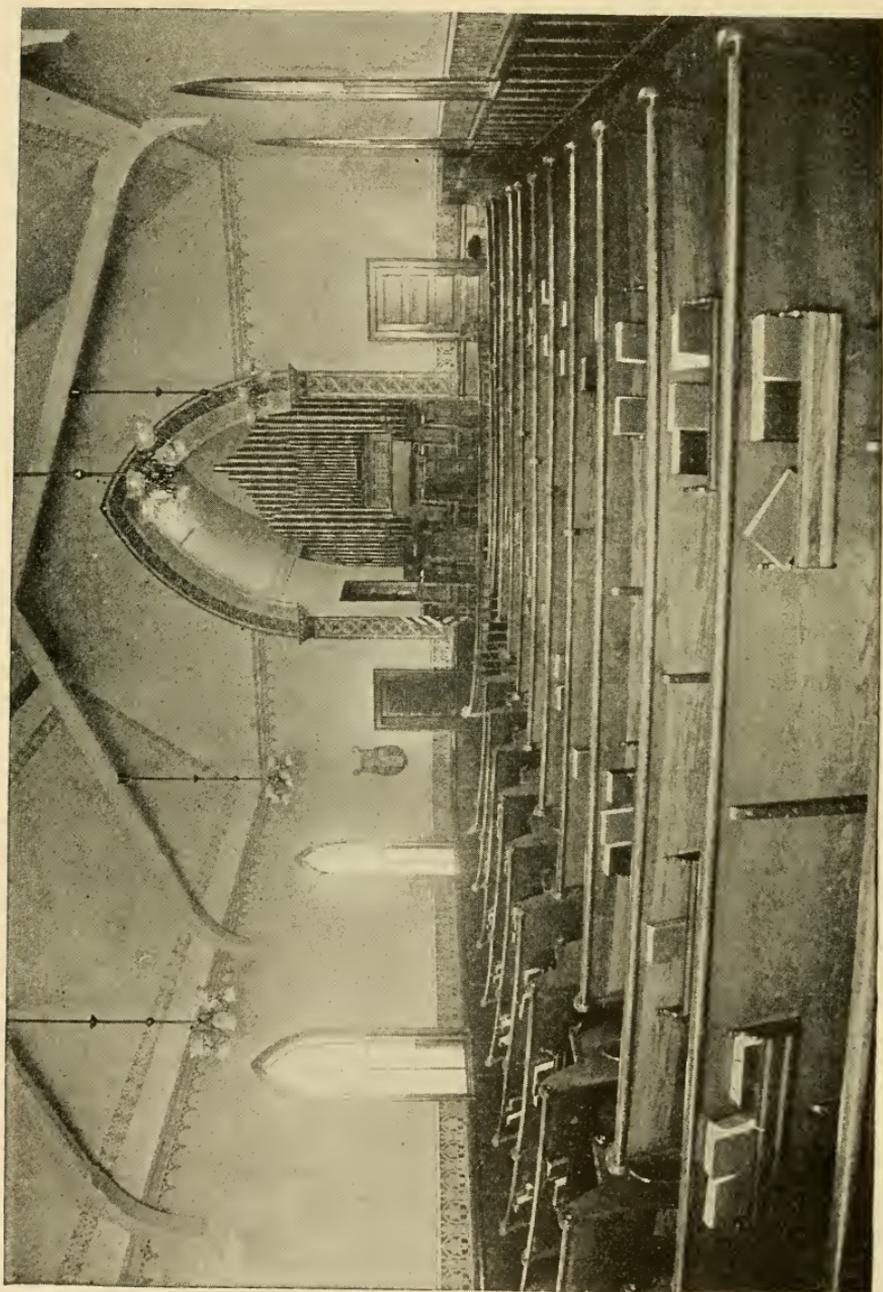
ILLUSTRATION 32. THE SECOND STORY AUDITORIUM, MAPLEWOOD METHODIST CHURCH, THE CHIEF EXIT FROM WHICH IS SHOWN IN ILLUSTRATION 34. A SECOND NARROW STAIRWAY, WHICH IS ALMOST UNUSABLE, IS AT THE RIGHT OF THE ORGAN

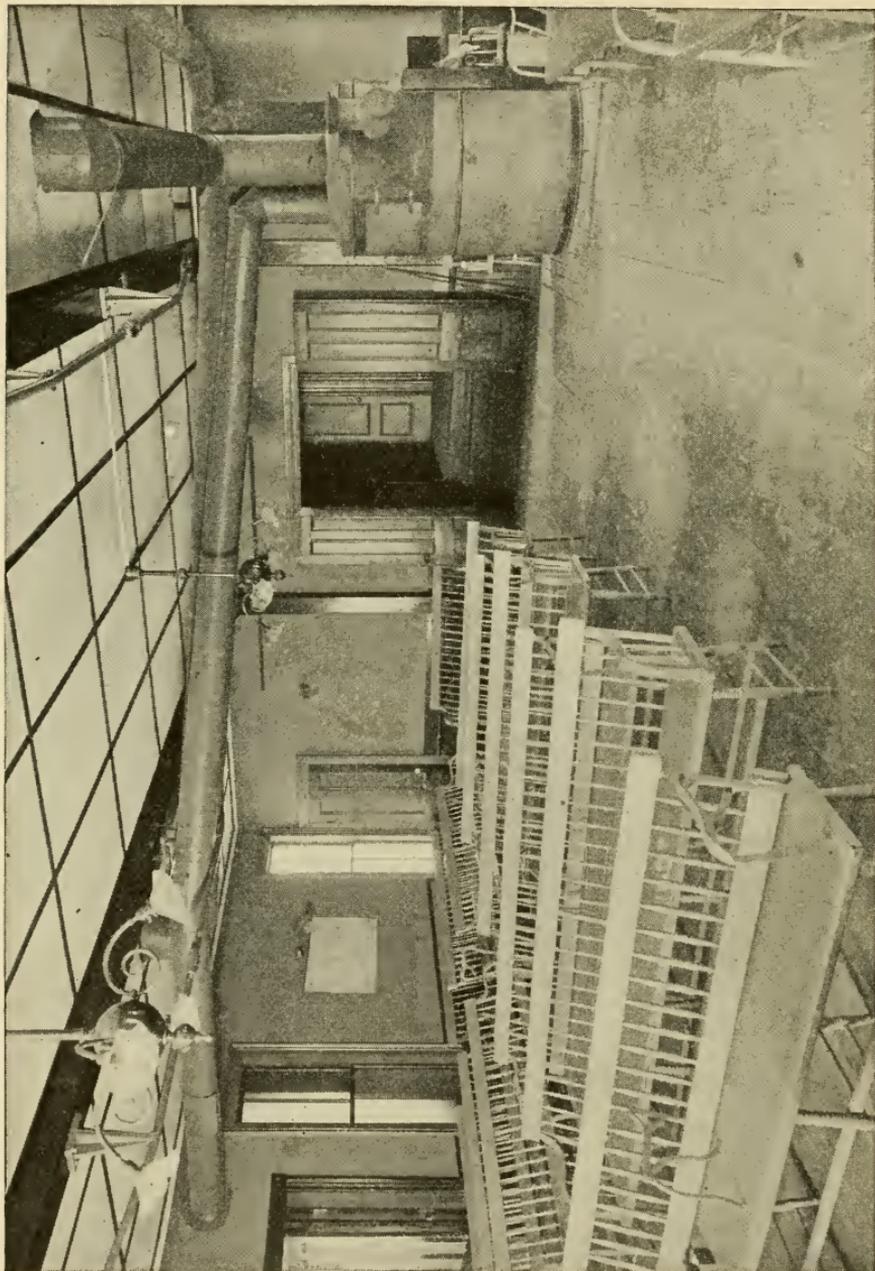
ILLUSTRATION 35. SHOWING THE IMPROPERLY PLANNED EXIT, THE UNSATISFACTORY SEATING ARRANGEMENTS, POOR LIGHTING AND INADEQUATE FURNISHINGS OF THE FIRST FLOOR SUNDAY SCHOOL ASSEMBLY ROOM OF THE LINDEN CONGREGATIONAL CHURCH

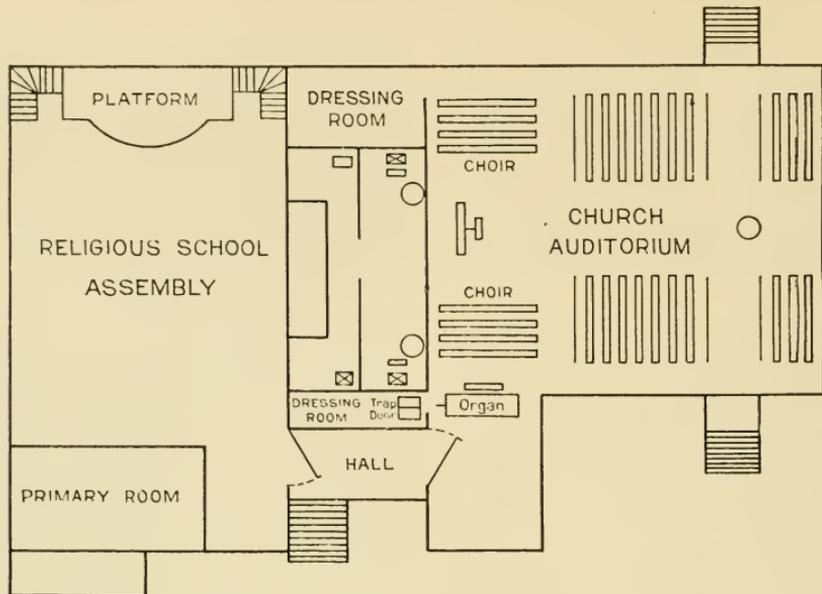
ILLUSTRATION 38. SHOWING INCONVENIENT ARRANGEMENT OF ROOMS AND DIFFICULTY OF PASSING AROUND ORGAN TO GET FROM SCHOOL ROOMS TO AUDITORIUM OF ST. LUKE'S EPISCOPAL CHURCH

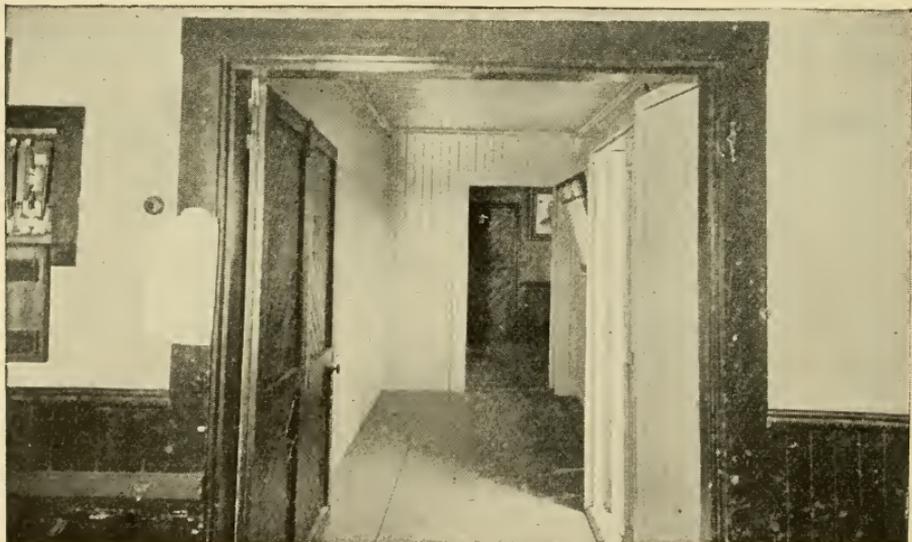
ILLUSTRATION 39. INADEQUATE FOYER AND CONNECTION BETWEEN RELIGIOUS EDUCATION ROOM AND AUDITORIUM IN ST. LUKE'S EPISCOPAL CHURCH

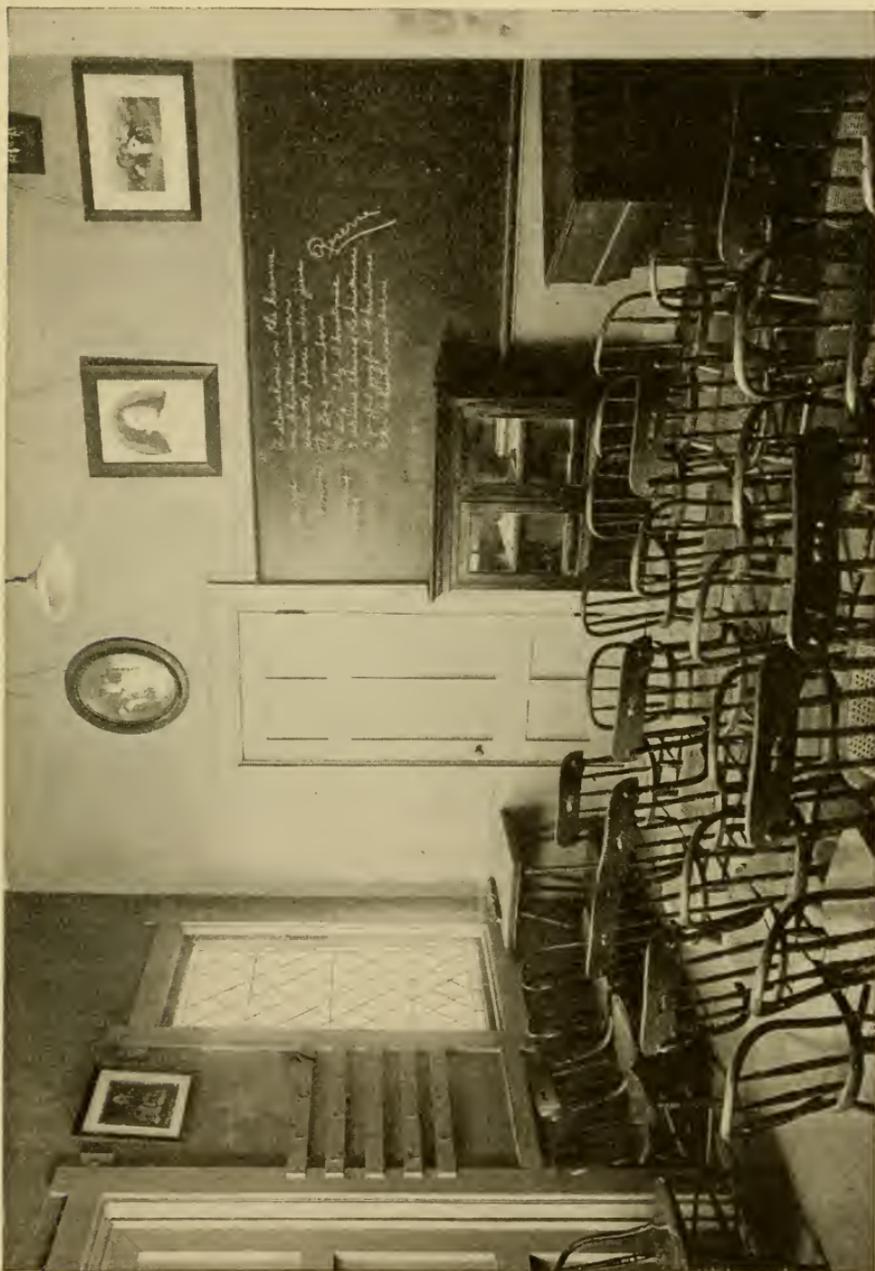
ILLUSTRATION 40. A PRIMARY CLASS ROOM, MAPLEWOOD CONGREGATIONAL CHURCH WITH INADEQUATE NATURAL AND ARTIFICIAL LIGHT. PICTURES TOO HIGH. EQUIPMENT MEAGER AND UNATTRACTIVE

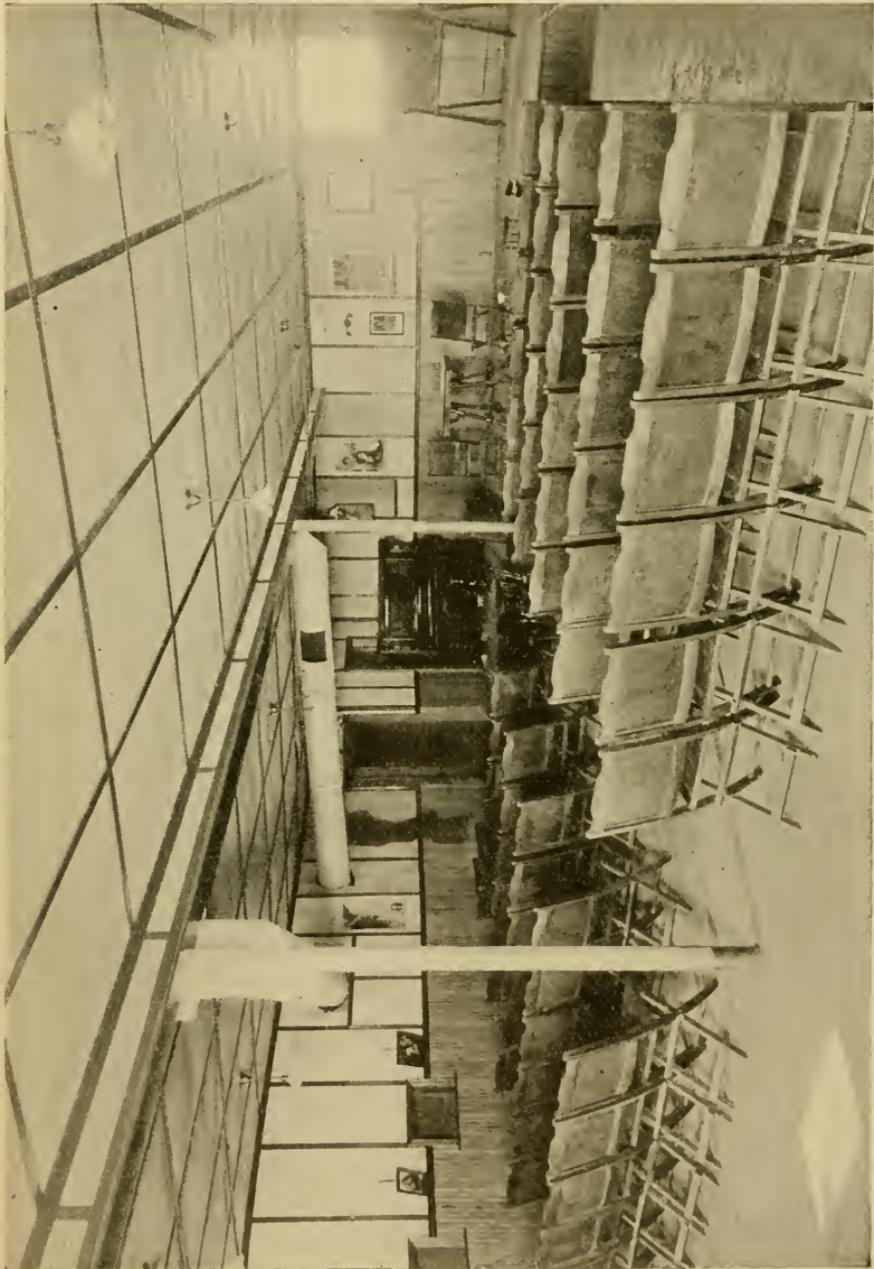
ILLUSTRATION 42. THE SUNDAY SCHOOL ROOM, LINDEN METHODIST CHURCH. COMPOSITION BOARD WALLS, CEMENT FLOOR, THE SECONDARY HEATING SCHEME AND THE POOR NATURAL LIGHTING CAUSE THIS BASEMENT ROOM TO RATE LOW

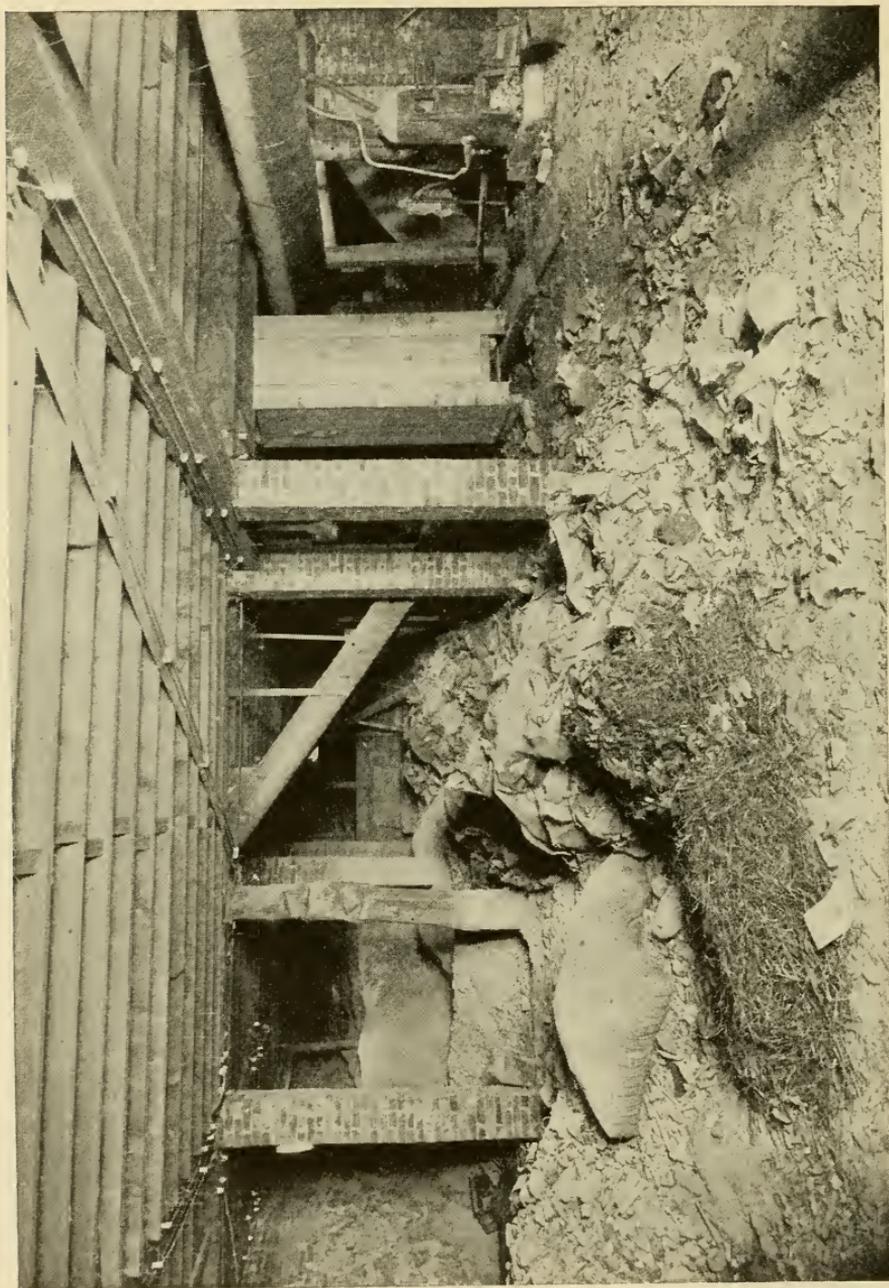
ILLUSTRATION 43. THIS BASEMENT IN THE MAPLEWOOD BAPTIST CHURCH PRESENTS MANY FIRE HAZARDS WHICH SHOULD NOT BE TOLERATED IN ANY PUBLIC BUILDING

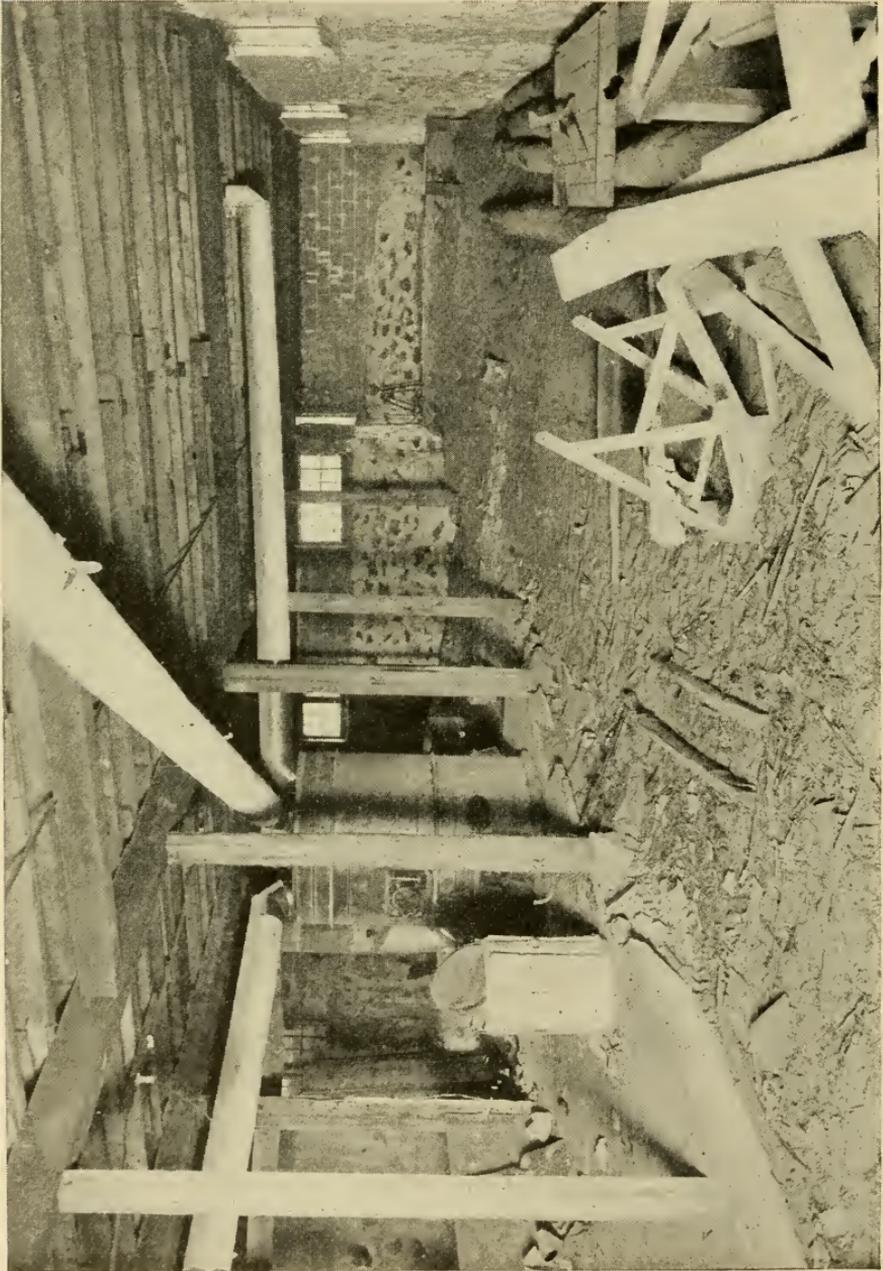
ILLUSTRATION 44. THE BASEMENT IN ST. LUKE'S EPISCOPAL CHURCH, THE LIGHTING AND ARRANGEMENT OF WHICH SHOULD HAVE BEEN PLANNED FOR PLAY AND RECREATION FOR CHILDREN

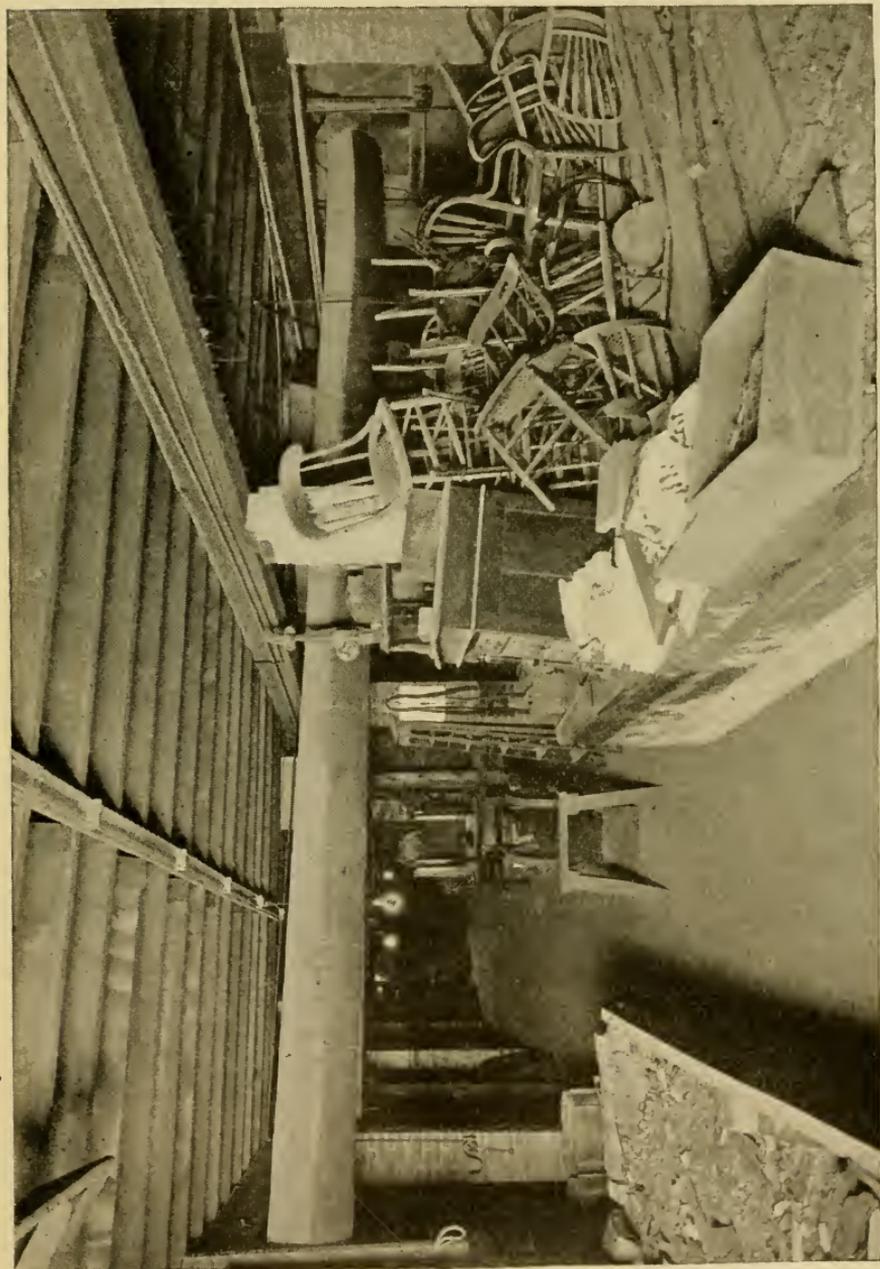
ILLUSTRATION 45. THE BASEMENT OF THE FIRST CONGREGATIONAL CHURCH. NOTE THE DEFECTIVE WIRING, JOINTS UNPROTECTED FROM THE DUCTS AND HEATERS, ONE OF THE FIVE HEATERS LOCATED IN THIS CONGESTED BASEMENT IS SEEN AT THE RIGHT

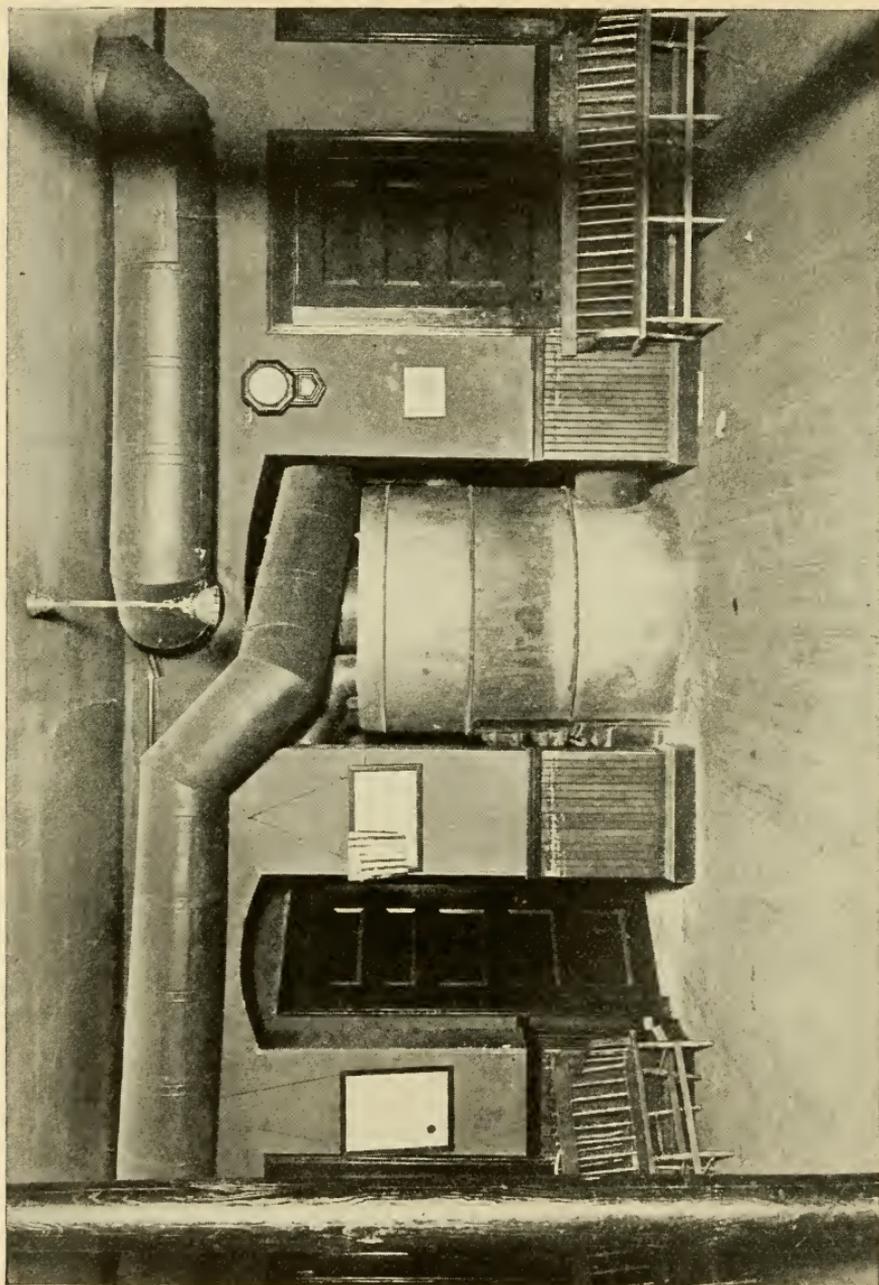
ILLUSTRATION 50. ONE OF THE UNPROTECTED FURNACES OF THE MYSTIC SIDE CONGREGATIONAL CHURCH FURNISHING A CONSTANT POSSIBILITY OF FIRE DANGER. THIS CONSTRUCTION SHOULD NEVER HAVE BEEN PERMITTED BY LAW

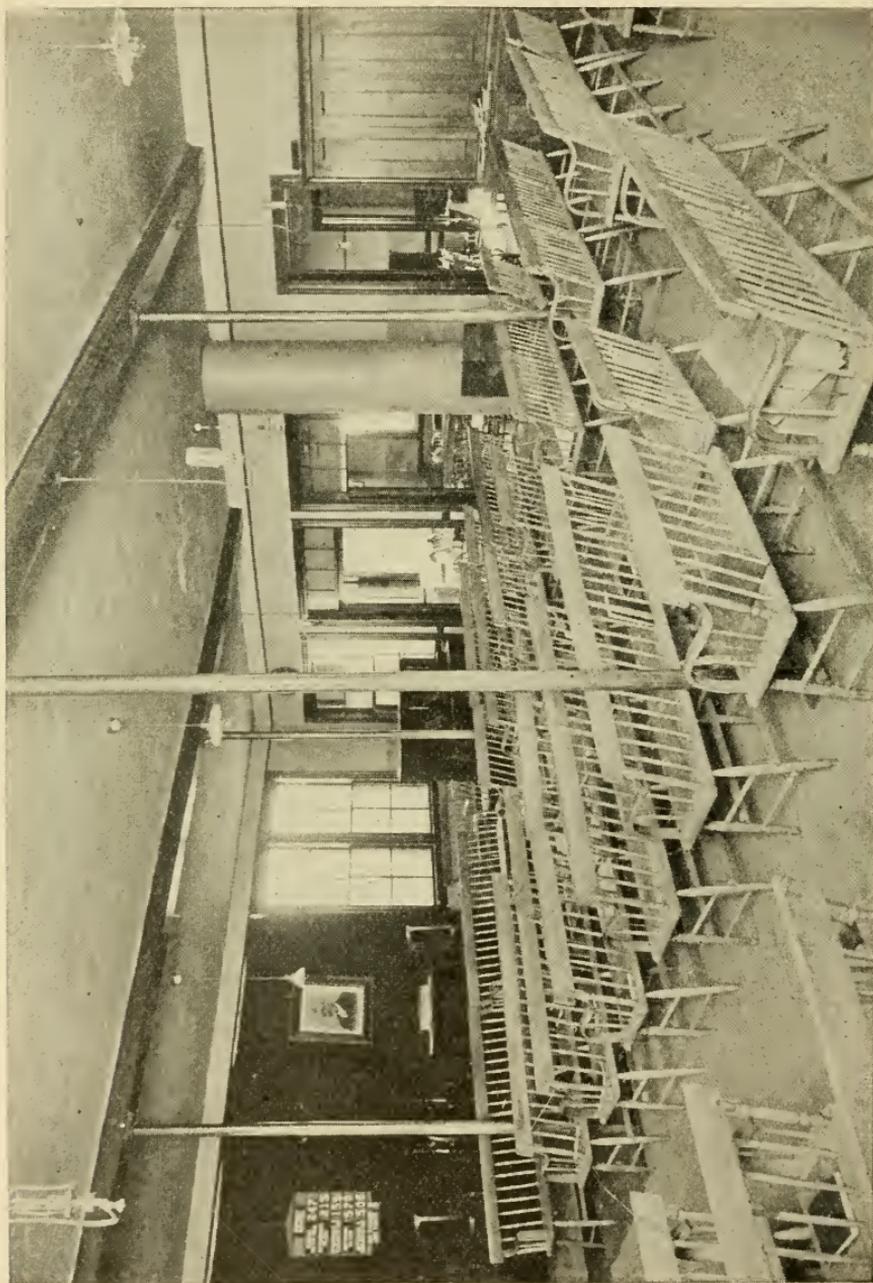
ILLUSTRATION 51. SHOWING THE SUNDAY SCHOOL ROOMS OF THE MAPLEWOOD METHODIST CHURCH. NOTE THE FLUE METHOD OF HEATING AT THE RIGHT CENTRE; THE INADEQUATE ARTIFICIAL LIGHTING AND THE UNDESIRABLE FURNITURE

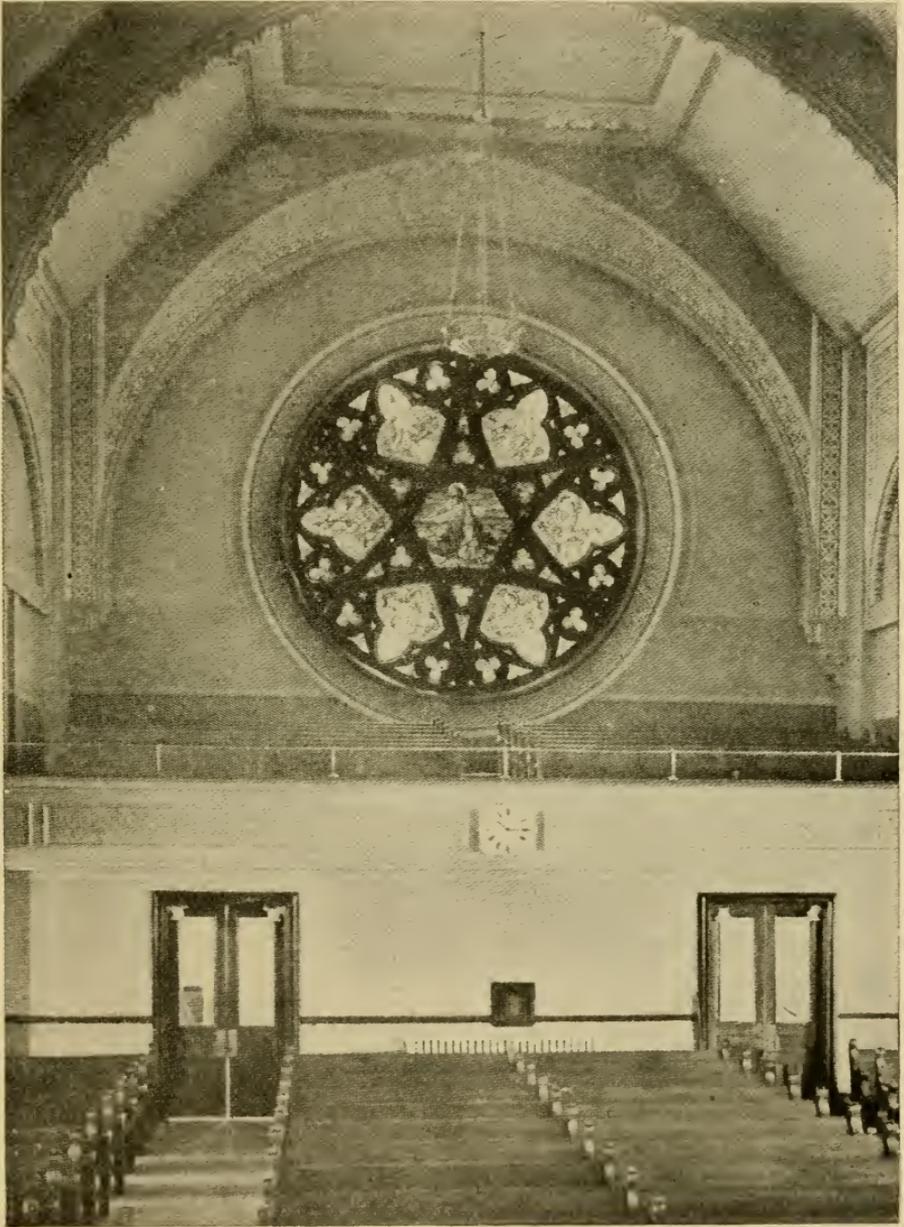
ILLUSTRATION 53. AN ATTRACTIVE INTERIOR OF THE CENTRE METHODIST CHURCH. THIS SHOWS THE SECOND STORY AUDITORIUM FLOOR WITH PART OF ITS THIRD STORY BALCONY, WHERE ABOUT 1000 PEOPLE MAY BE SEATED. AUDITORIUMS, UNLESS IN STRICTLY FIREPROOF BUILDINGS, SHOULD BE AT GROUND LEVEL

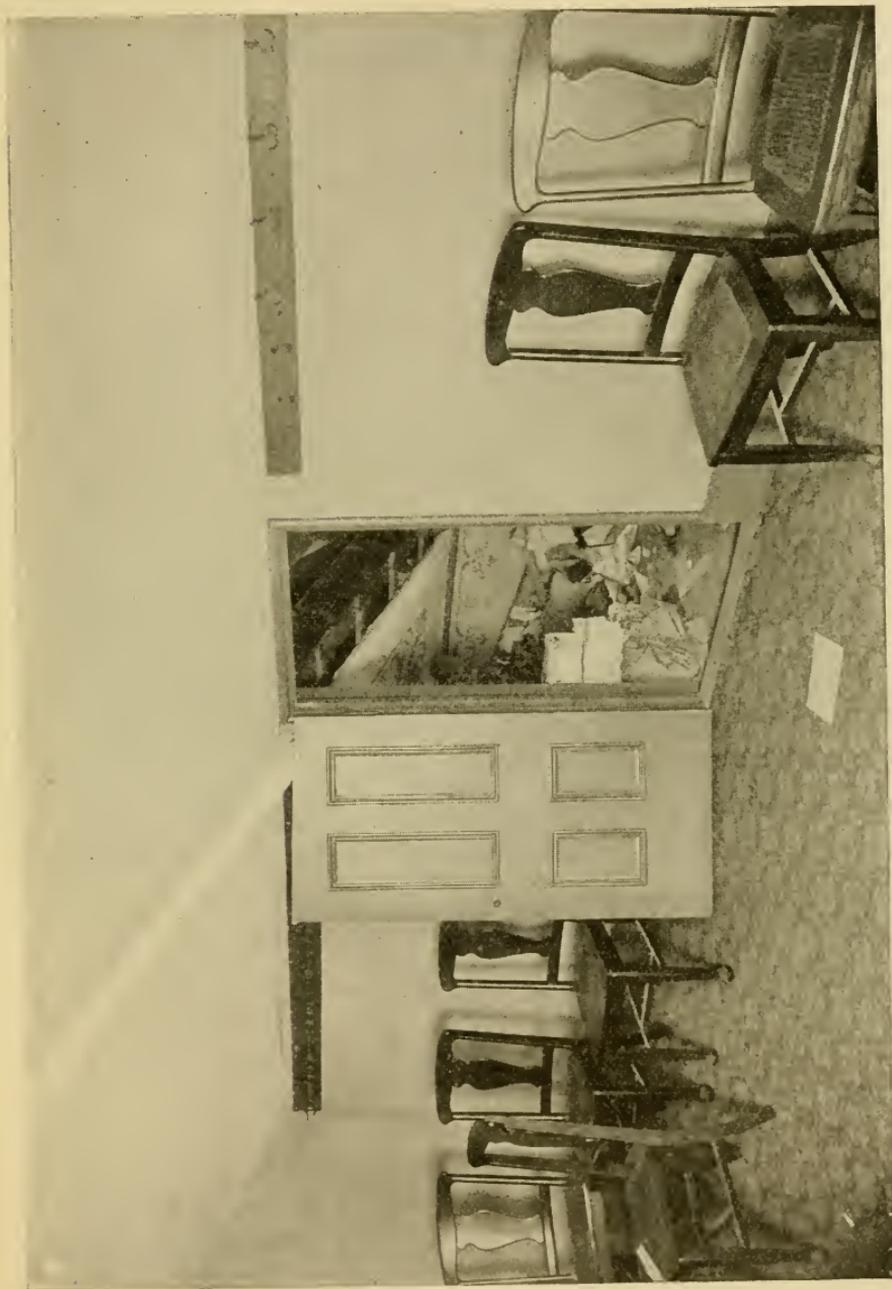
ILLUSTRATION 54. EVIDENCE OF EXTREME DISREGARD OF FIRE DANGERS IN A STORE ROOM DIRECTLY UNDER THE RAFTERS OF THE MAPLEWOOD BAPTIST CHURCH. MUCH EASILY COMBUSTIBLE MATERIAL HAD BEEN TOSSED INTO THIS STORE ROOM

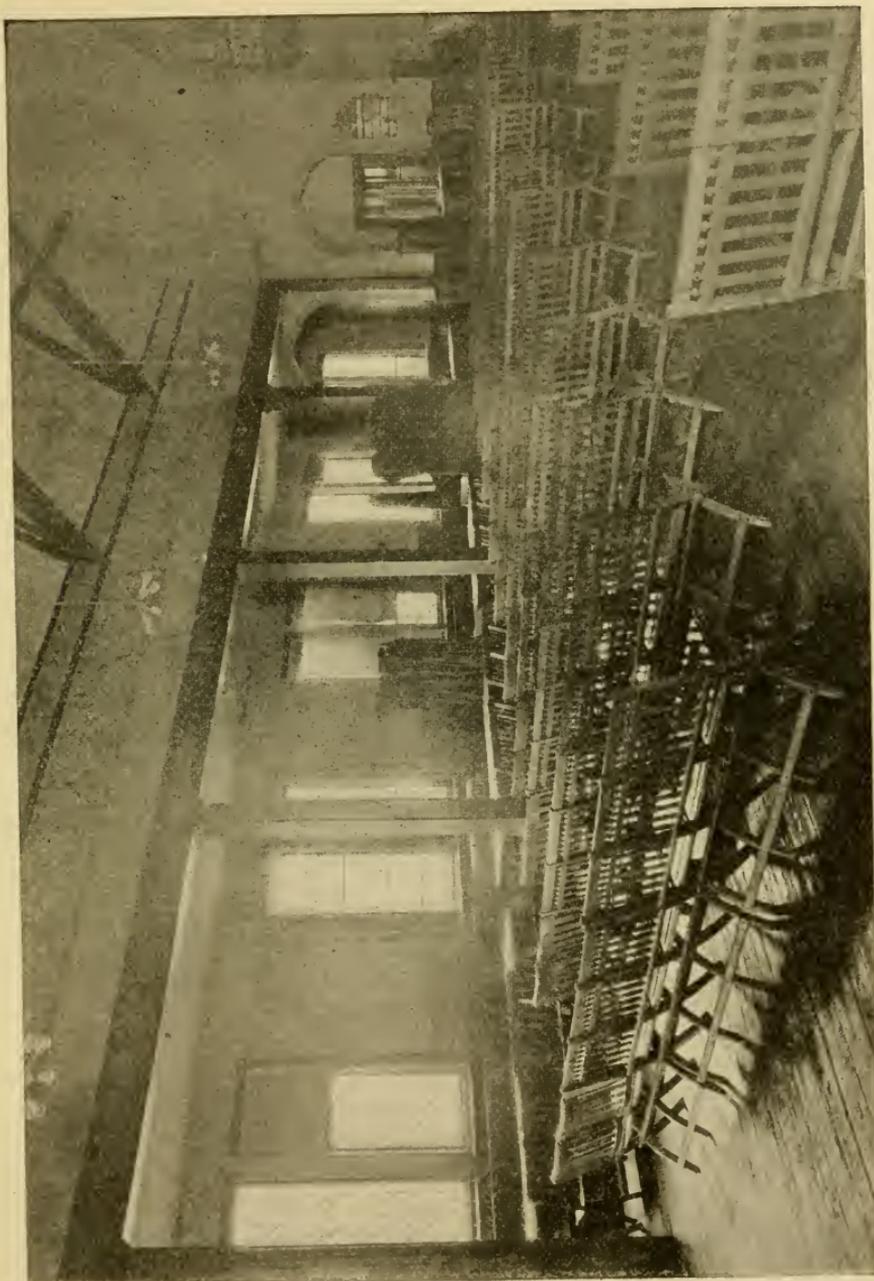
ILLUSTRATION 56. TEMPORARY SUNDAY SCHOOL ASSEMBLY ROOM OF ST. PAUL'S EPISCOPAL CHURCH. CURTAINS ON WIRES PROVIDE CLASSROOMS ABOUT EDGE OF ROOM. BAD CONDITION OF FLOOR, POOR KIND OF ARTIFICIAL LIGHTING AND INADEQUATE NATURAL LIGHTING SHOWN

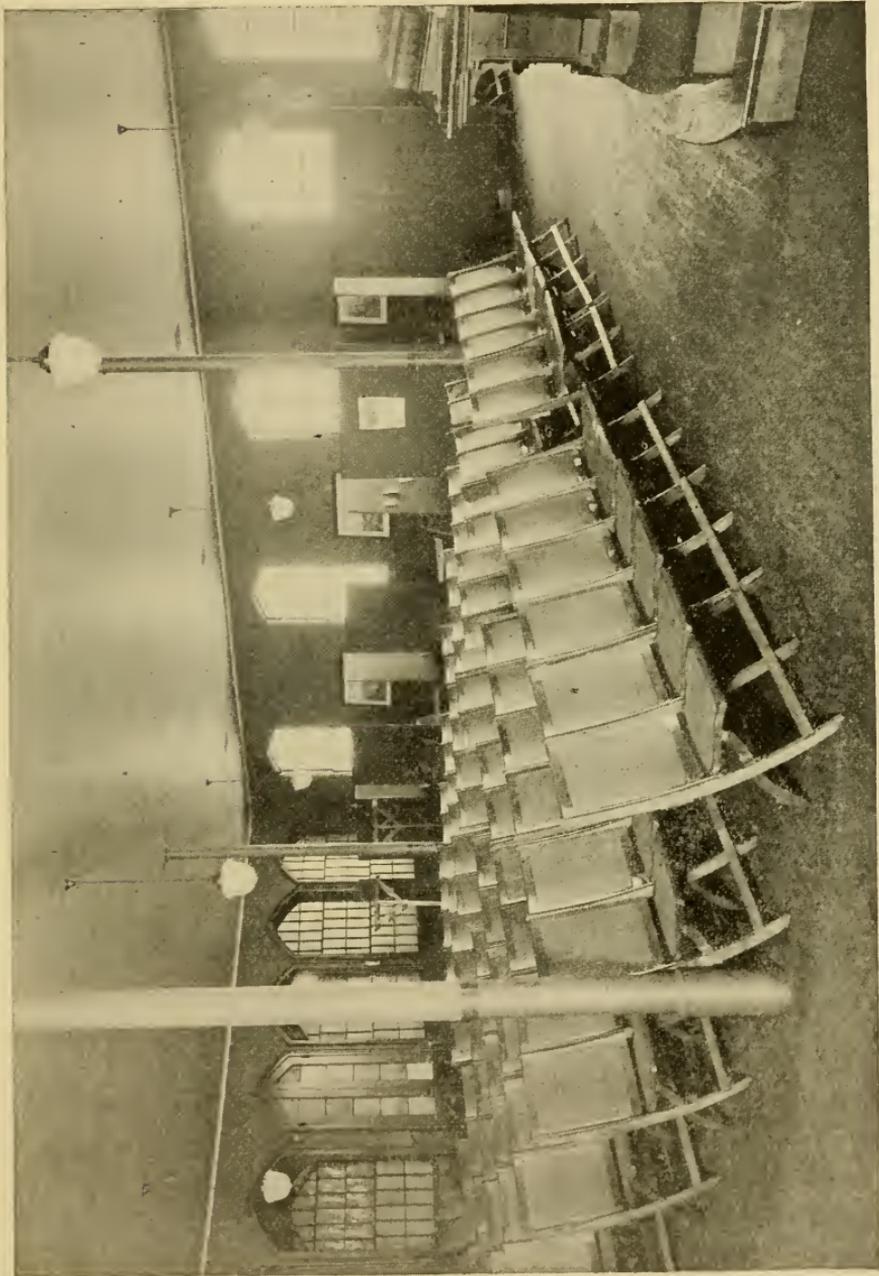
ILLUSTRATION 57. SUNDAY SCHOOL ASSEMBLY ROOM, FIRST CONGREGATIONAL CHURCH SHOWING THE MAKE-SHIFT SCREENED CLASS ROOMS AT SIDE OF ROOM. NOTE THE SPLENDID TYPE OF ELECTRIC FIXTURES USED

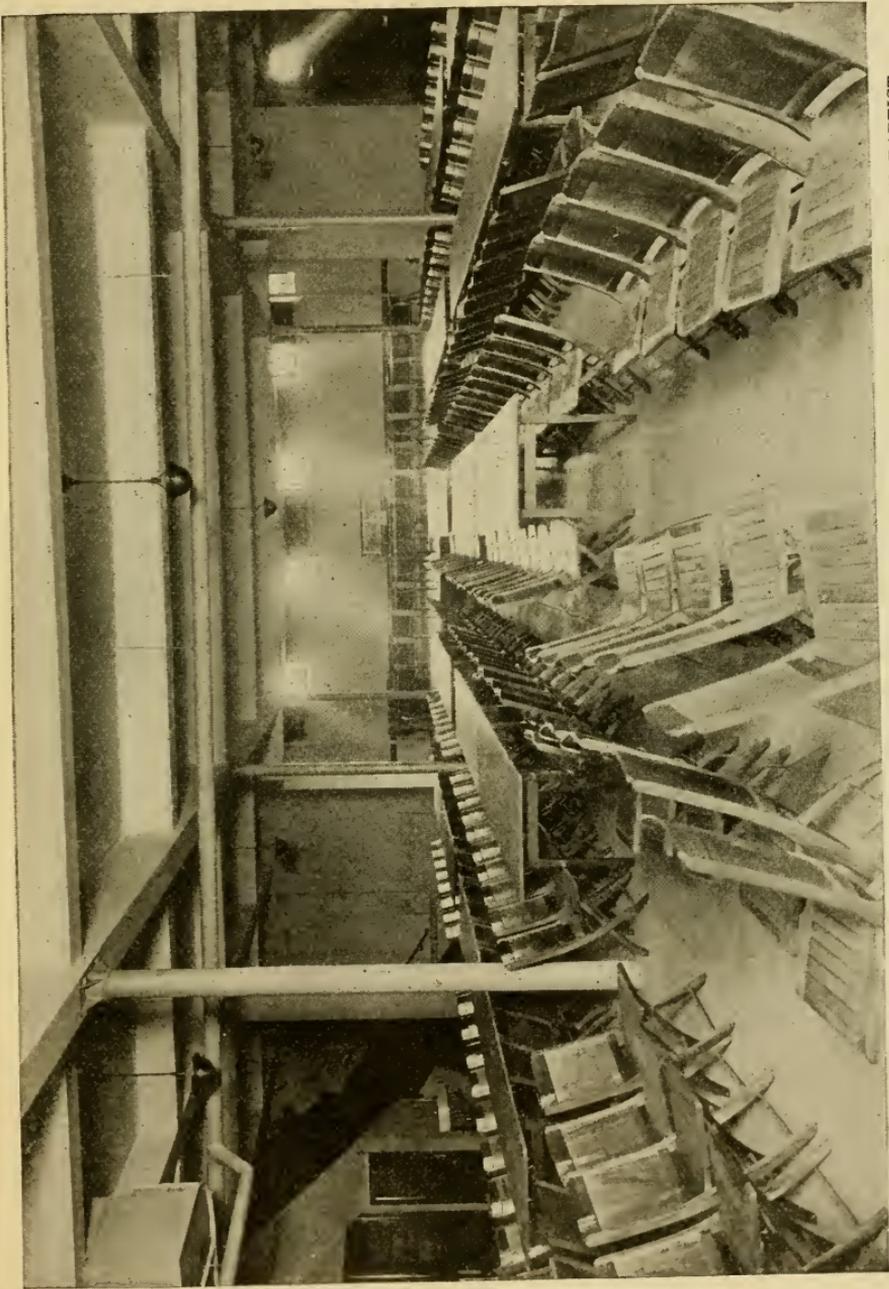
ILLUSTRATION 58. THE WELL-APPOINTED BANQUET ROOM IN THE BASEMENT OF THE FIRST BAPTIST CHURCH. SPLENDID INDIRECT ARTIFICIAL LIGHTING BUT INADEQUATE NATURAL LIGHTING

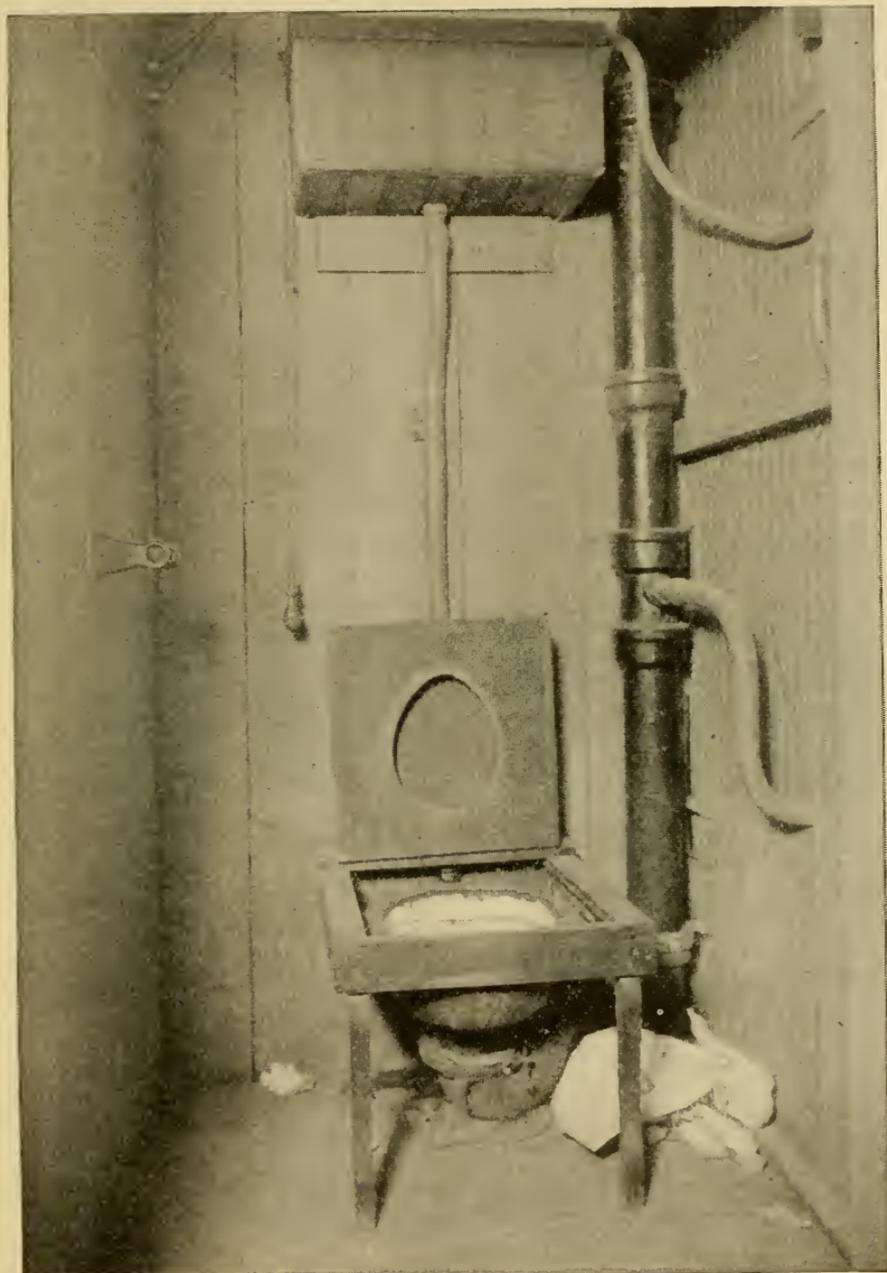
ILLUSTRATION 60. THE EXTREMELY UNSANITARY TOILET PROVISIONS OF THE ST. LUKE'S EPISCOPAL CHURCH

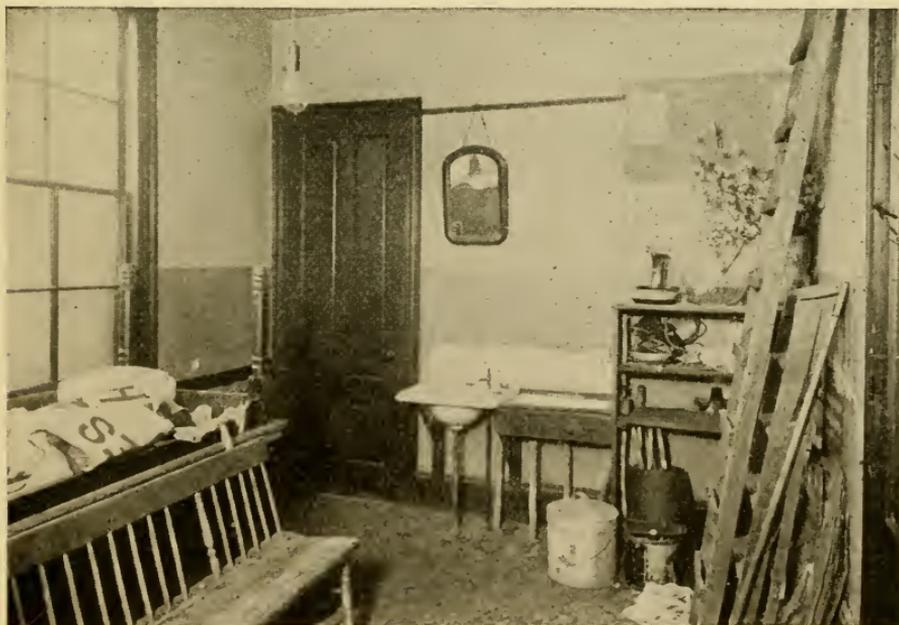
ILLUSTRATION 61. UNATTRACTIVE, POORLY-EQUIPPED KITCHEN OF THE MAPLEWOOD METHODIST CHURCH
